- May 15-16, 2018 over 16 inches of rain fell on Southern Washington County (9.45 inches of which in 45 minutes).
- Garretts Mill Road Bridge over Israel Creek was overtopped and the flood plain inundated.
- The bridge and roadway was rendered unusable.

- Washington County issued an RFP for Design-Build Replacement Project on July 5, 2018.
- Building Systems Inc. (Contractors) / Brudis & Associates, Inc. (Designers) was Awarded the Contract on August 24, 2018.
- The Project involved Hydraulically In-Kind Replacement of the Bridge and Roadway.

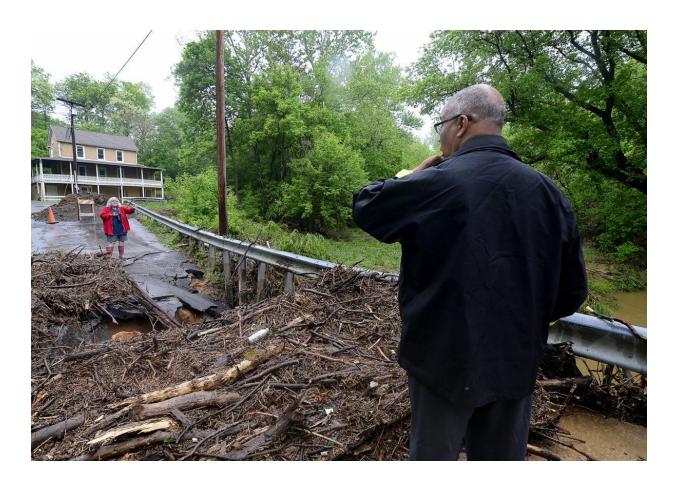
Source: Julie E. Greene May 29, 2018; South County resident Sophia Turner talks to Maryland Lt. Gov. Boyd Rutherford across a damaged bridge on Garretts Mill Road in Knoxville on May 16, 2018 during his visit to inspect damage left after strong thunderstorms caused severe flash flooding overnight.

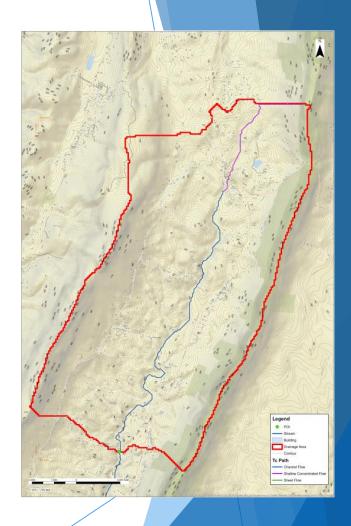
Summary of Discharges for Israel Creek at Garretts Mill Road

- Win TR-20 & GIS Hydro was used
- Drainage Area = 9.8 Sq. Miles
- No gage data available
- Calibration conducted using FRR equation and Tasker upper 67% confidence limits
- Existing condition land use was used

Existing	Ultimate
	Development*	Development
RETURN	Conditions WinTR-20	Conditions WinTR-20
PERIOD (yr)	Estimate (ft3/s)	Estimate (ft3/s)
2	640	620
10	1,780	1,740
25	3230	3180
50	4,150	4,080
100	5,190	5,140
500	8,150	8,070

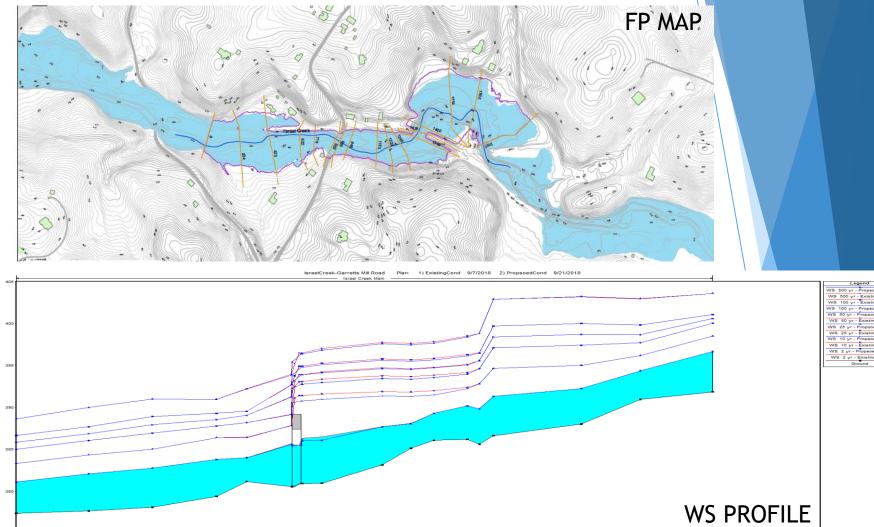
HEC-RAS Model used to accomplish the following goals:

- Assess the impacts of proposed design on Shear Stress, Flooding Conditions and Overtopping Conditions
- Find optimum size of proposed structure
- Provide hydraulic parameter for scour analysis

- No adverse impacts to the WSEL
- Hydraulic in-kind replacement with 26 ft long 28 ft wide CON/SPAN O-SERIES bridge
- Scour protection Not an issue due to rock outcrops at shallow depths

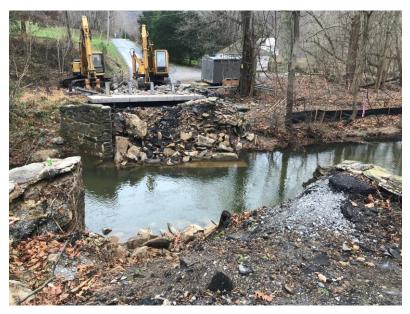
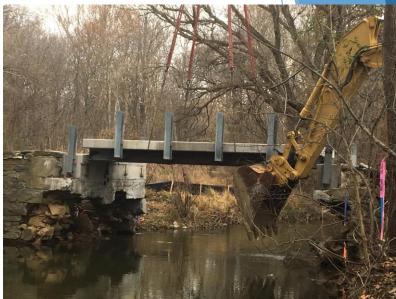
Demolition

Bridge was lifted by crane.

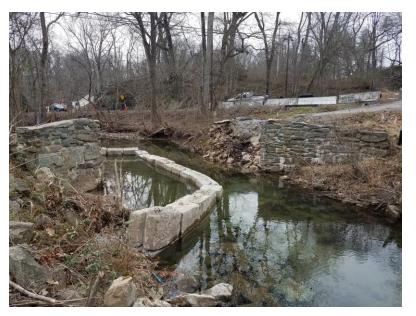
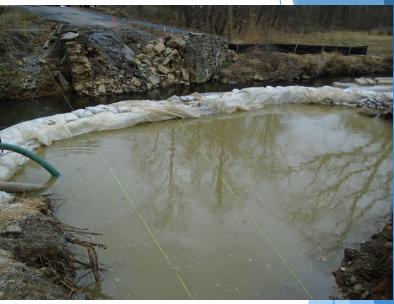
In-Stream Work

In-stream diversion used, but high levels of rainfall and underground flow made this option unusable.

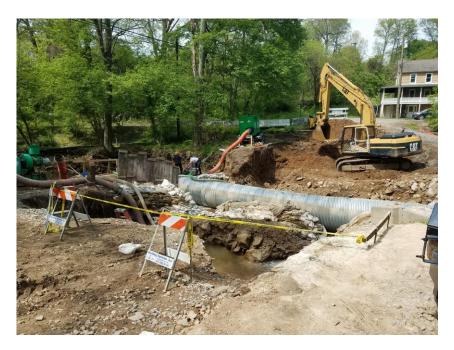
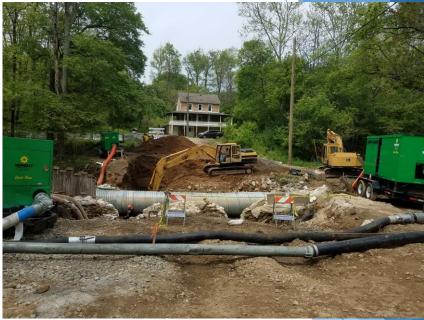
In-Stream Work

Pump and pipe diversion was ultimately used with three additional pumps evacuating the work area for subfooting concrete pours.
